DEPARTMENT OF TRANSPORTATION**DIVISION OF ENGINEERING SERVICES**

Office of Structural Materials

Contract #: 04-0120F4Cty: SF/ALA Rte: 80 PM: 13.2/13.9File #: 69.15**SOURCE INSPECTION REPORT****Resident Engineer:**Pursell, Gary**Address:** 333 Burma Road**City:** Oakland, CA 94607**Report No:** SIR-002077**Date Inspected:** 30-Apr-2010**Project Name:** SAS Superstructure**OSM Arrival Time:** 700**Prime Contractor:** American Bridge/Fluor Enterprises, a JV**OSM Departure Time:** 1900**Contractor:** Zhenhua Port Machinery Company, Ltd (ZPMC), Changxing Island **Location:** Chang xing Dao, Shanghai**Quality Control Contact:** Mr. Don Walton**Quality Control Present:** Yes No**Material transfer:** Yes No N/A**Sampled Items:** Yes No N/A**Stock Transfer:** Yes No N/A**OK to Cut:** Yes No N/A**Rebar Test Witness:** Yes No N/A**Delayed/Cancelled:** Yes No N/A**Other:** Coating Inspection**Bridge No:** 34-0006**Component:** See below**Bid Item:** 77, 78, 79**Lot No:** B #204**Summary of Items Observed:**

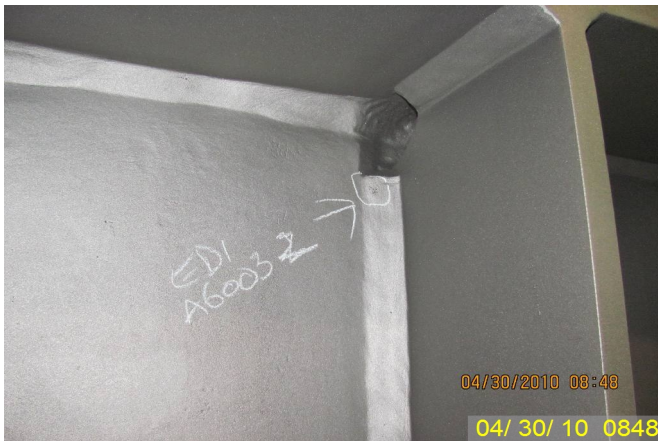
1. An inspection was requested on the Tower Spare struts ED1-A 6001- 1 to 8 and ED1-A 6003- 1 to 8 - 16 nos for Surface profile and Residual chlorides test inspection vide request no. T 341 at Blasting workshop no. 2. This Caltrans inspector observed, ABF inspectors Mr. Don Walton, Mr. Turtle, Mr. Stone and Mr. Yue performing inspection check of Profiles. All the struts found rejected by ABF Inspectors for Low profile and porosity/ weld repairs. ABF welding inspectors from Tower came in to painting shop to find out the depth of porosities observed after Blasting. They have been asked by Mr. Don Walton to mark it for Weld repair at Shop if the porosities are deep, i.e. if not in surface. Two struts from the rejected lot of 16 nos, ED1-A 6001- 3, 4 have been offered for Surface profile and Residual chlorides test again after rectification of marked points vide Notification no. T 343. Residual chloride test have been conducted by ZPMC Inspectors and the results found to be approximately 20 us/cm which is acceptable as per contract documents. The surface profile on these two struts found to be in the range of 78 to 82 which is acceptable as per contract documents. International protective coatings technical service representative Mr. Li peng was found present during the course of this inspection process. (Photograph of porosities at welding of ED1-A 6003-2 is attached)

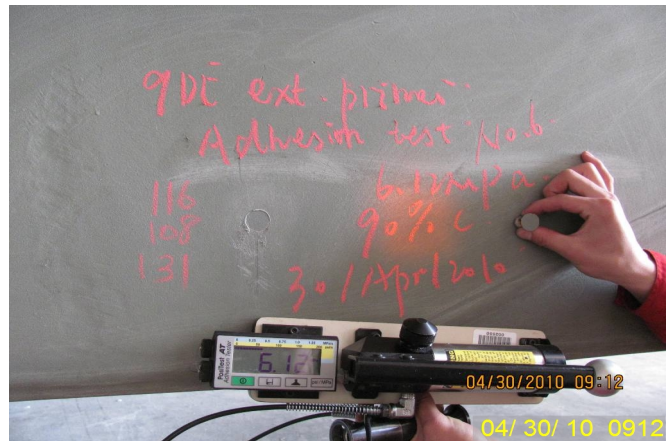
3. An inspection was requested on the OBG segment 9DE for adhesion test of external surfaces vide request no. 3239 at Paint shop 1. This Caltrans inspector observed, ABF inspectors Mr. Turtle and Mr. Stone performing said inspection check on external surfaces at 6 places. The results carried out with calibrated pull off adhesion tester found to be in the range of 6.12 to 14.07 MPA which is acceptable as per contract documents. International protective coatings technical service representative Mr. Li peng was found present during the course of this inspection process. Photograph of Adhesion test at 6th place over the external surfaces of cross beam is attached. The result at this place is found to be 6.12 Mpa with 90 % cohesion failure.
